U.S. Army Toxic and Hazardous Materials Agency

## Enhanced Preliminary Assessment Report:

### Midway Army Housing Units Kent, Washington

November 1989

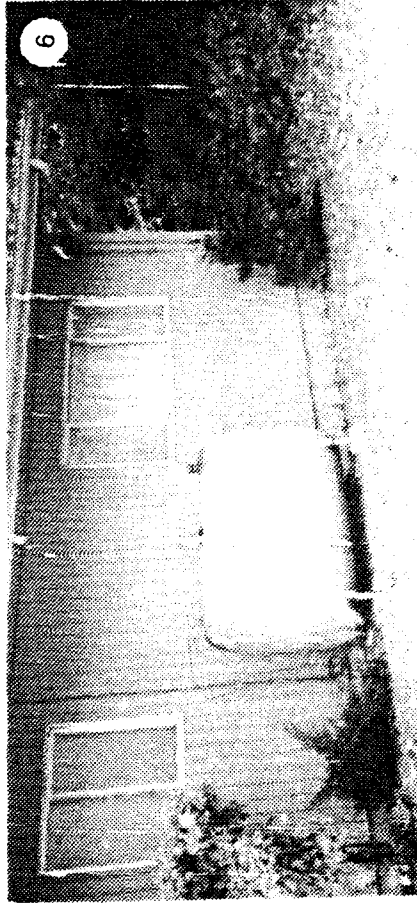
4. A gravel drainage ditch shown at center along entire length of the view.
5. Above-ground fuel-oil storage tank, next to the wall of the housing unit; in the foreground is the gravel drainage ditch.

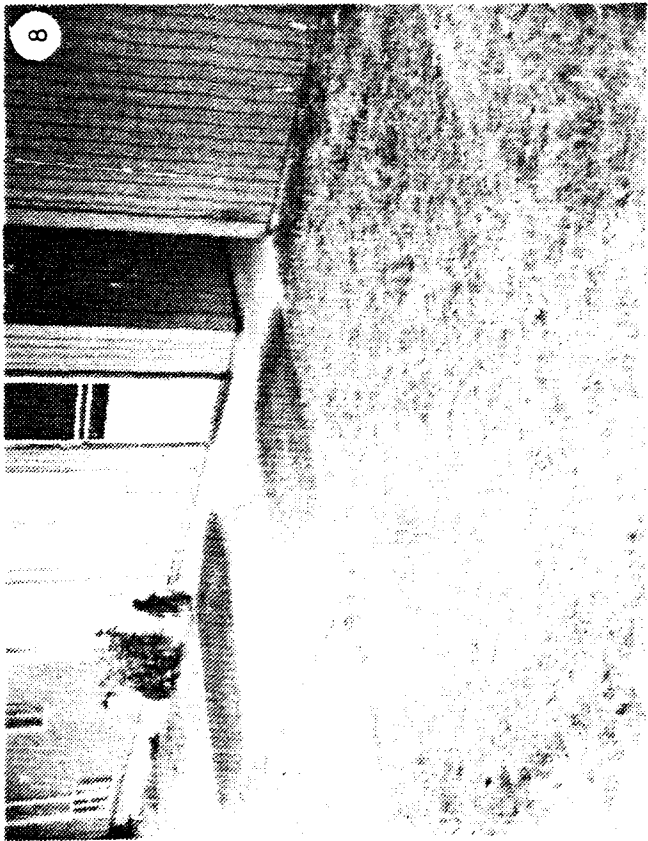
There are presently 30 500-gallon underground tanks that contain fuel oil for the forced-air furnaces. Originally there were 32 underground tanks at this site; however, about three years ago, two tanks at units #30 and 32 were replaced because of heating problems. These problems were traced to water intrusion in the fuel-oil storage tanks. At the time of failure, the two tanks were replaced with smaller 275-gallon above-ground storage tanks. The two original underground tanks remain in place at these two units, however. It is not known whether any product was lost from these tanks prior to discovery of water-intrusion problems.

6. Closer view of above-ground fuel-oil storage tank.
7. The inlet pipe for an underground fuel-oil storage tank; underground tanks that leaked oil were abandoned in place, and above-ground tanks were installed for storage of fuel oil; thus, both underground and above-ground tanks are in use at this site.

- Remove and replace the 32 underground fuel-storage tanks; sample soils in the tank excavations for petroleum contamination and remediate any problems encountered.

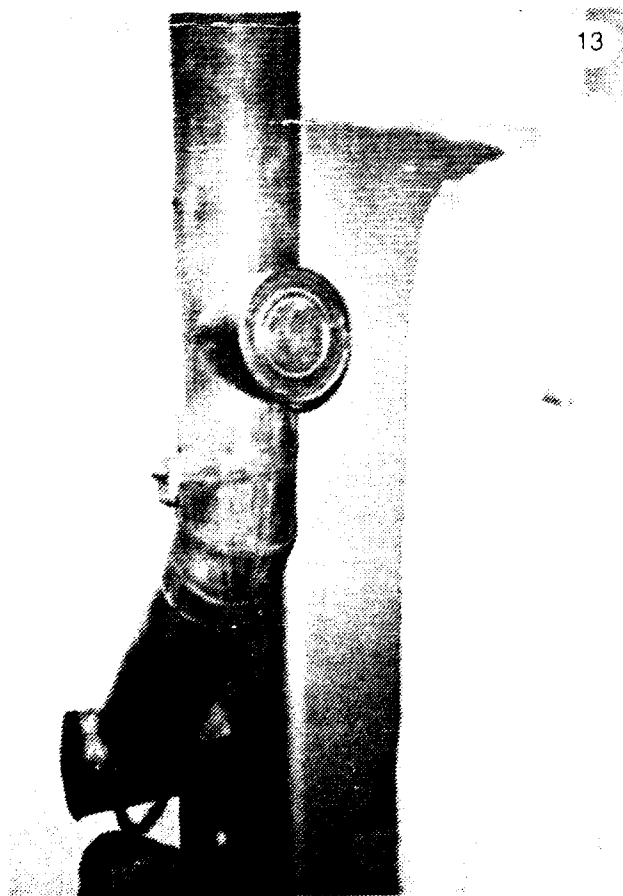
13. Insulated hot water tank; the fiberglass insulation material shows evidence of cracking; furnace and vent pipe are also seen to the left of the hot water tank.
